**CALSPAN ON-SITE AMBULANCE CRASH INVESTIGATION**

**SCI CASE NO.: CA12032**

**VEHICLE: 2009 CHEVROLET C4500 / ROADRESCUE TYPE I AMBULANCE**

**CRASH DATE: JULY 2012**

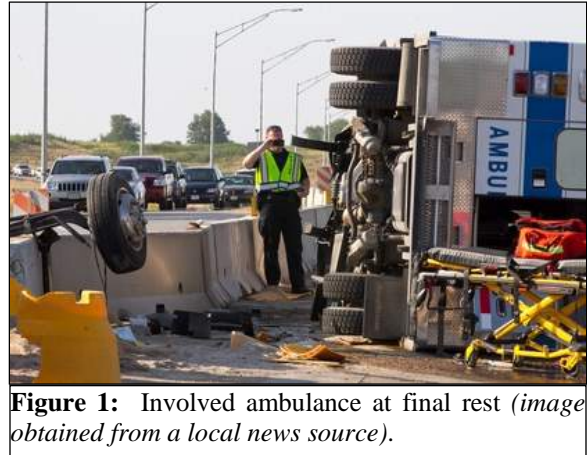
**Figure 1:** Involved ambulance at final rest (image obtained from a local news source).

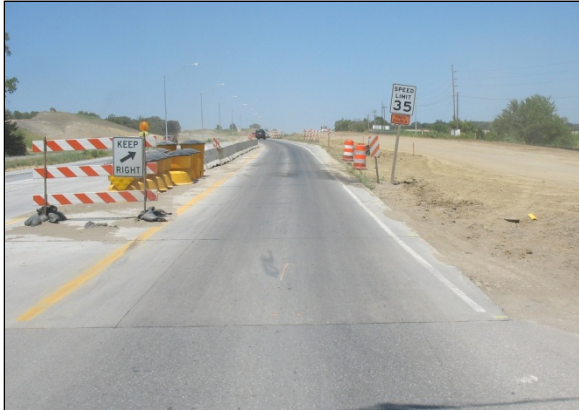
The first crash event occurred as the right aspect of the ambulance’s frontal plane impacted the forward aspect of the Ford’s left plane within the northeast intersection quadrant. Sideswiping impact forces, in combination with the driver’s attempted avoidance input, redirected the ambulance left toward the center aspect of the north intersection leg. The Ford, its front wheels already aligned with a positive angle due to its turning status, maintained a right-arching trajectory. It departed the east roadway edge immediately north of the northeast intersection quadrant and proceeded to final rest within the construction zone.

**Figure 4:** View of the northbound lane and Event 1 impact location (tire mark in center of image).

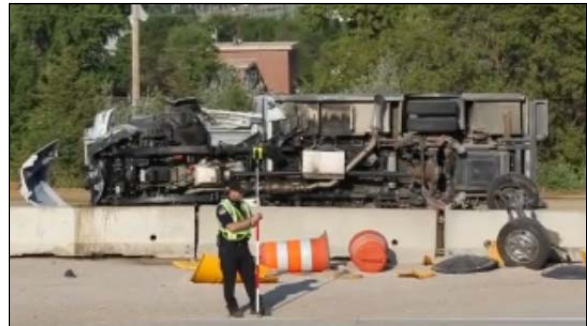
While maintaining forward movement, the ambulance straddled the barrier. During this sequence, the ambulance's front axle sheared from its suspension mounts and was displaced rearward. The right front tire then engaged the saddle compartment housing the low-voltage batteries, which partially separated the compartment from its chassis mounts. As the ambulance maintained its trajectory, the front axle completely separated from the chassis. Subsequently, the ambulance initiated a right side-leading rollover and flipped off the barrier, completing one-quarter turn (Event 4). It slid a short distance within the northbound lane before coming to rest within the roadway on its right plane, facing north (**Figure 5**). During the rollover, the rearward portion (foot end) of the stretcher disengaged from the locking clamp mechanism and the stretcher was partially displaced [right laterally].

**Figure 5:** View of the overturned ambulance at final rest (image obtained from a local news source).

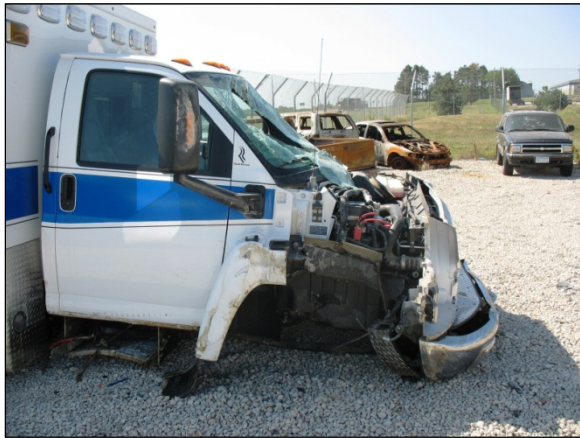
Damage to the exterior of the ambulance from the multiple event crash was present on the front, right, and undercarriage planes of the vehicle. Direct contact damage associated with the Event 1 impact was located on the frontal plane and extending onto the right plane in a sideswiping fashion. On the frontal plane, damage began at the bumper corner and extended 10 cm (3.9 in) left laterally. Extension down the right plane measured 122 cm (48 in), beginning at the right front bumper corner and extending to the right front fender aft of the right front axle position (**Figure 7**). Within the damage pattern were body surface abrasions and minor deformation, with direct contact evident to the right front wheel and bumper corner. The Truck Deformation Classification (TDC) assigned to the ambulance for the Event 1 impact was 01FRLS5.

**Figure 7:** Event 1 damage on the right plane of the Chevrolet's cab.

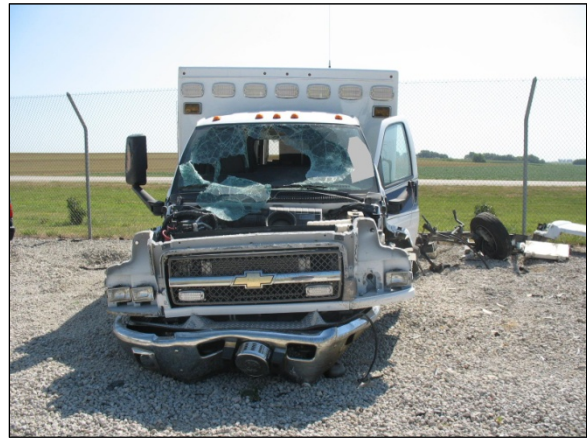
**Figure 8:** Frontal plane damage to the Chevrolet ambulance associated with Events 2 and 3.

Frontal plane damage was attributed to the Events 2 and 3 impacts with the impact attenuators and concrete median barrier (**Figure 8**). Event 3 damage extended onto the undercarriage plane. Frontal plane damage associated with Event 2 was present across the entire 202 cm (79.5 in) frontal end width, with minor bumper deformation. Due to the non-fixed status of the impact attenuators and their purpose, in combination with the vehicle's size and mass, the Chevrolet did not sustain significant damage attributable to this event. Although the exact number of sand barrels impacted could not be determined, due to the distribution of the event impacts across the ambulance's frontal plane, the TDC assigned was 12FDEW1.

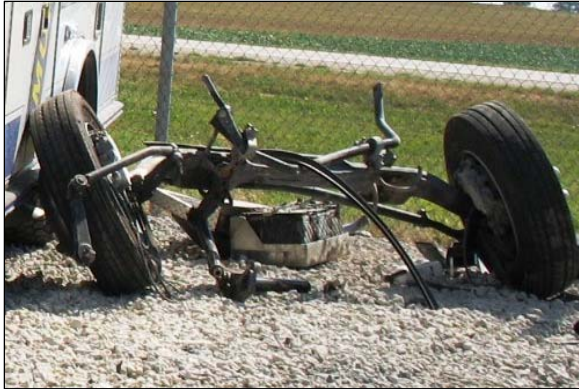
The concrete median barrier impact associated with Event 3 of the crash sequence was located at the left aspect of the Chevrolet's frontal plane. Frontal plane damage began 50 cm (19.7 in) left of center and extended to the left front bumper corner. This included longitudinal and vertical displacement of the front bumper beam, with significant extension onto the vehicle's undercarriage as the ambulance mounted the barrier. As the ambulance overrode the barrier, the left front axle engaged the barrier's leading edge and was sheared from the vehicle's chassis (**Figure 9**). The leading edge of the patient compartment module, at chassis level aft of the left front door of the cab, contacted and was deformed by the barrier (**Figure 10**).

**Figure 9:** Separated front axle of the Chevrolet ambulance, attributable to Event 3.

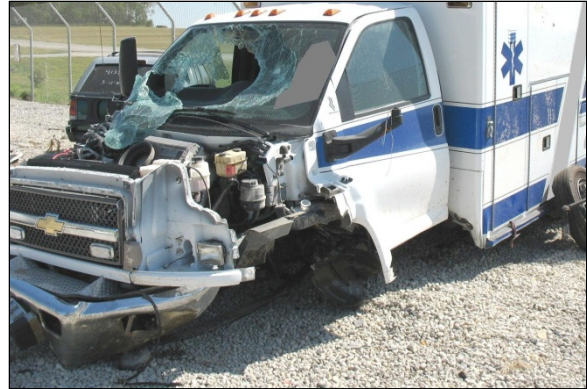
**Figure 10:** Damage associated with the Event 3 impact and engagement to the Chevrolet ambulance.

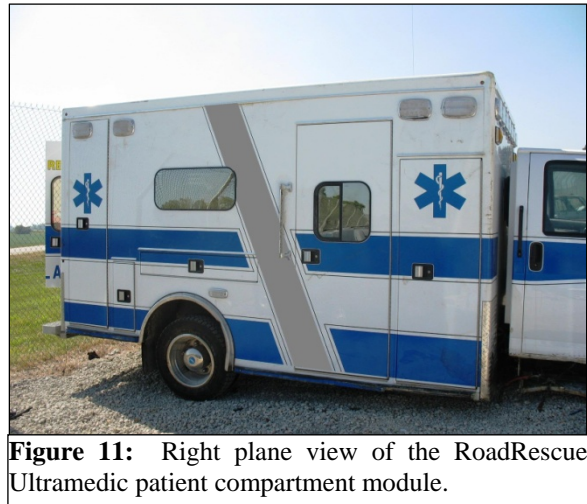
The Chevrolet's trajectory and positioning on top of the concrete barrier ultimately resulted in a right side-leading rollover sequence (Event 4). The rollover sequence's initiation was a flip-over type, and the ambulance completed one-quarter turn. Direct contact damage, consisting of minor body deformation and surface abrasions, was distributed across the ambulance's entire right plane. None of the right plane glazing sustained damage. The TDC assigned to the Chevrolet ambulance for the Event 4 rollover sequence was 00RDAO1. The ambulance's right plane is depicted in **Figure 11**.

**Figure 11:** Right plane view of the RoadRescue Ultramedic patient compartment module.

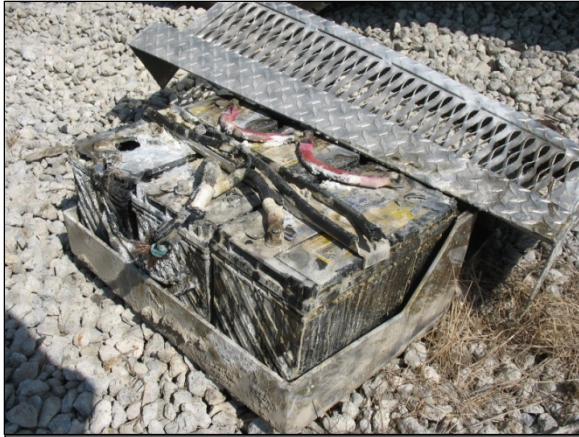
Due to the partial separation of the battery compartment during the crash sequence, an electrical short circuit developed as a fragment of deformed metal bridged the battery terminals. Resulting sparks ignited a small post-crash fire (Event 5) that was fed by leaking battery fluids and surrounding polymer components.

The right plane saddle compartment housing the vehicle's low-voltage (12-V) battery system, which consisted of three parallel-mounted batteries, was separated from the vehicle as a result of the rollover sequence.

**Figure 12:** Separated battery compartment and fire-damaged batteries of the Chevrolet ambulance.

One of the negative terminals of one of the batteries was pulled from the casement, which caused battery fluid leakage. This battery fluid coated the adjacent batteries. It was determined that a separated piece of steel fascia bridged the terminals of the compromised battery and an adjacent battery. This resulted in a series of sparks that ignited the leaking battery fluid, and the post-crash fire (Event 5) developed. Fire damage was limited to the separated battery packs and their compartment housing, with minimal extension of thermal discoloration and deformation to the fiberglass and polymer body panels beneath the right front door. The separated battery compartment and fire-damaged batteries are depicted in **Figure 12**.

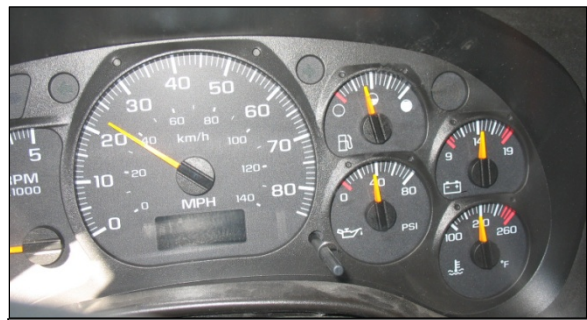
Remaining damage within the cab's interior consisted of occupant contact to the right armrest of the left front seat and left lower instrument panel. Other notable findings within the cab included the frozen status of the instrument panel's gauge cluster (**Figure 13**). The speedometer was stuck at 37 km/h (23 mph), the tachometer was stuck at 1000 RPM, the fuel indicator level was stuck slightly below 1/2 of a tank, the oil pressure indicated 241 kPa (35 PSI), the temperature gauge read approximately 93 Celsius (200 Fahrenheit) degrees, and the batteries' voltage was stuck at 14-V.

**Figure 13:** Frozen instrument panel gauge cluster within the Chevrolet ambulance.

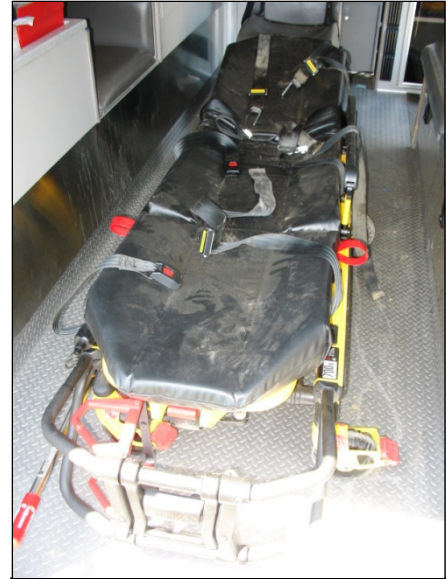
**Figure 14:** Stryker Performance PRO-XT stretcher within the Chevrolet.

During the crash sequence, lateral forces associated with the rollover exceeded the locking clamp mechanism's load strength and the clamp released. This allowed the rearward portion (foot end) of the stretcher to move unrestricted. However, due to the short duration and low magnitude of the rollover and its forces, the stretcher was not fully displaced. The right aspect of the forward portion (head end) of the stretcher remained engaged within the antler bracket. As such, the stretcher simply pivoted until the rear aspect (foot end) contacted the base of the bench seat. No apparent damage was sustained by the stretcher or its fastener system as a result of the multiple event crash sequence, despite the apparent release of the stretcher's locking pin from the locking clamp. The antler bracket cradled the forward guide wheels, despite the overturned status of the ambulance.

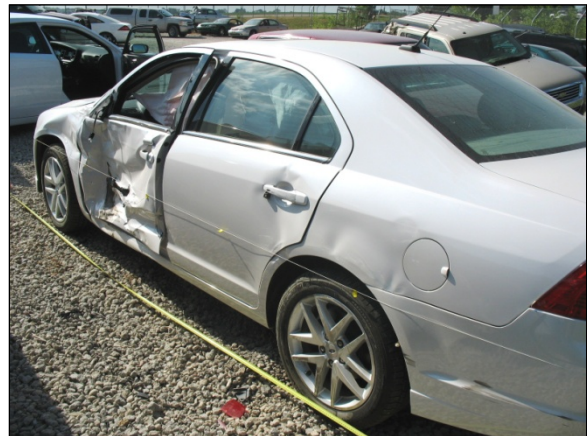
**Figure 16:** Left plane view of the Event 1 damage sustained by the Ford.

Damage attributed to Event 1 of the crash was located on the left plane, primarily in the area of the left front door (**Figure 16**). Direct contact damage measured 351 cm (138.2 in) in length and was distributed along the left front door, left A-pillar, left front fender, left B-pillar, left rear door, and left rear fender. This included minor body deformation with surface abrasions, and related crash forces has resulted in the deployment of the Ford's left Inflatable Curtain (IC) and left front seat back-mounted side impact air bags.

The direct and induced damage (Field-L) began 26 cm (10.2 in) forward of the left front axle and extended 391 cm (153.9 in) rearward. A residual crush profile documented at mid-bumper level produced the following results: C1 = 0 cm (0 in), C2 = 0 cm (0 in), C3 = 1 cm (0.5 in), C4 = 1 cm (0.5 in), C5 = 14 cm (5.5 in), and C6 = 0 cm (0 in). Maximum crush measured 15 cm (5.9 in). The Collision Deformation Classification (CDC) assigned to the Ford for the Event 1 impact was 07LDAW2.
